TECHNICAL REPORT ARCCB-TR-02016

**CHARACTERIZATION OF EXPLOSIVELY BONDED AND
FIRED TANTALUM LINERS APPLIED TO 25-MM GUN TUBES**

NOVEMBER 2002

**US ARMY ARMAMENT RESEARCH,
DEVELOPMENT AND ENGINEERING CENTER**
Close Combat Armaments Center
Benét Laboratories
Watervliet, NY 12189-4000

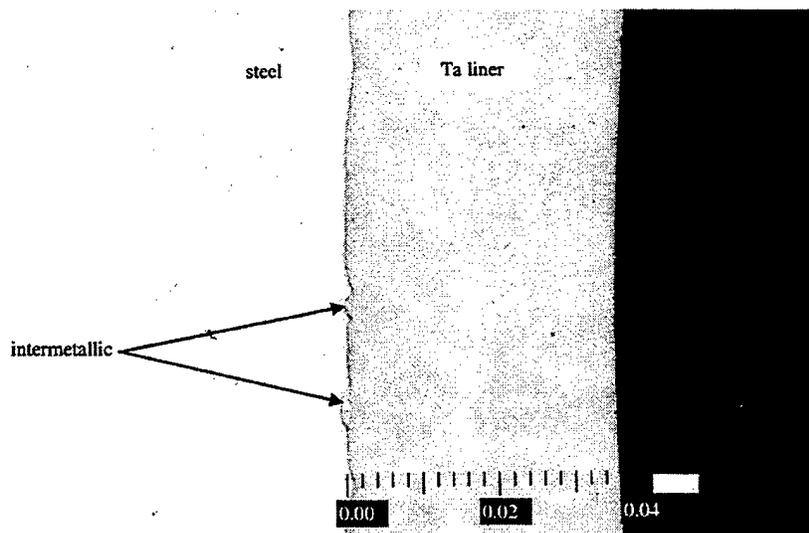
Metallographic examination of the unfired specimen revealed a fully dense, defect-free liner material (Figure 13). Along much of the steel/tantalum interface there appeared a hard, brittle intermetallic at all locations. The waveform of the interface is illustrated in Figure 14.

Figure 13. Metallurgical features of Tube A at 50X.

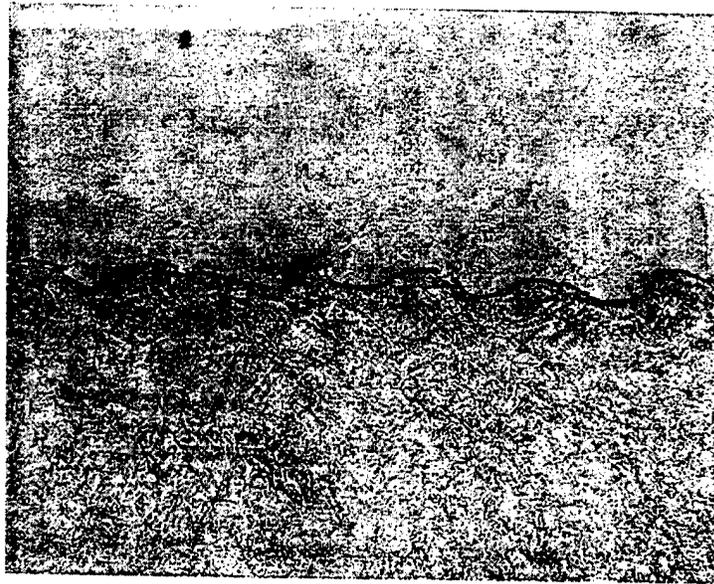
Figure 14. Waveform exhibited by Tube A in axial direction at 500X.

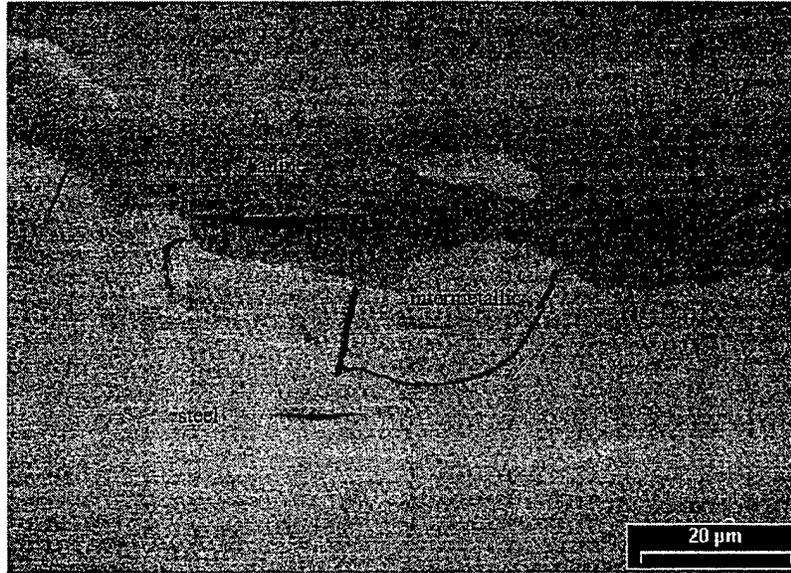
The liner of Tube B exhibited the same bulk features as Tube A. The liner was dense and defect-free and along much of the interface, a brittle and cracked intermetallic was present. The microhardness of the intermetallic in this tube was also $\sim\text{HK}_{50}$ 900. An image illustrating the comparative hardness values of the steel, intermetallic, and tantalum liner is given in Figure 15. Besides minor plastic deformation, the steel microstructure appeared relatively unaffected by the explosive bonding process. The one location examined in which the microstructure of the steel was noticeably altered occurred at the 8-inch location (Figure 16b). Although the microstructure is altered, there is no significant hardening or softening of the steel, so the ramifications of this insofar as fatigue life is concerned are unknown.

Figure 15. Tube B hardness variations of steel, liner, and intermetallic.

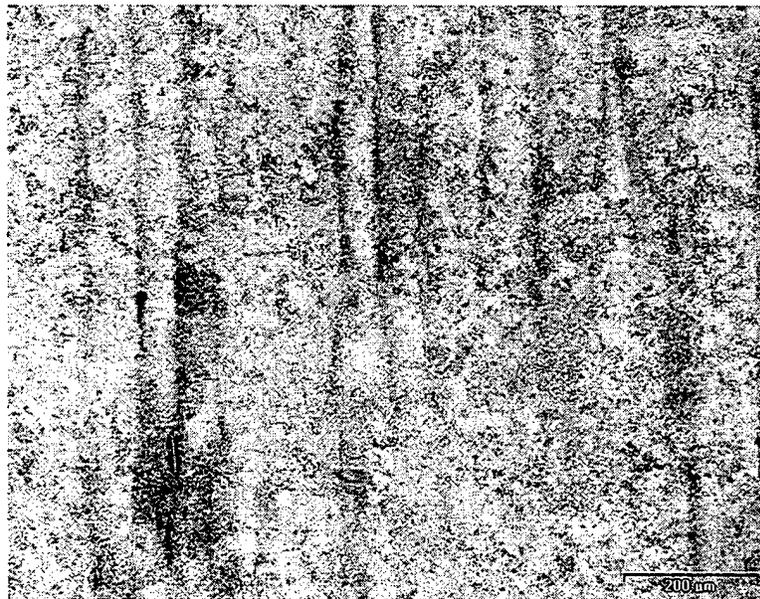
Etching revealed banding parallel to the tube axis throughout the steel substrate of Sample A, as shown in the cross-section of Figure 25. There are many occurrences of inclusions oriented along the bands. These features reflect the quality of material used for the manufacture of this gun tube.

Figure 25. Substrate steel of unfired explosively bonded tantalum-coated gun tube at magnification 200X. This cross-section is perpendicular to the bore and parallel to the tube axis.

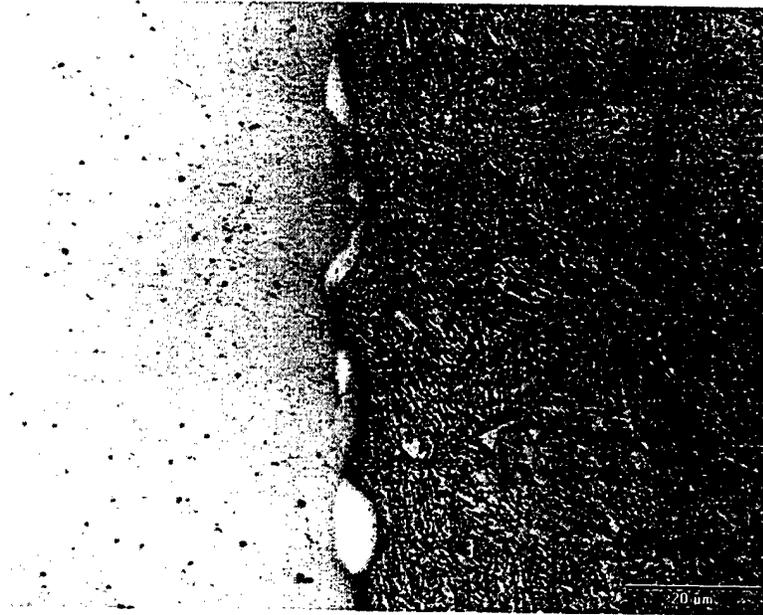
Also observed was the formation of an intermetallic phase found at random locations throughout the irregular explosively bonded tantalum/steel interface, as shown in Figure 26. As no heat-affected zone is seen adjacent to these regions, this intermetallic phase was produced without high heating. These results are consistent with the cold welding process attributed to explosive bonding.

Figure 26: Explosively bonded tantalum/steel interface of Sample A at magnification 2000X.

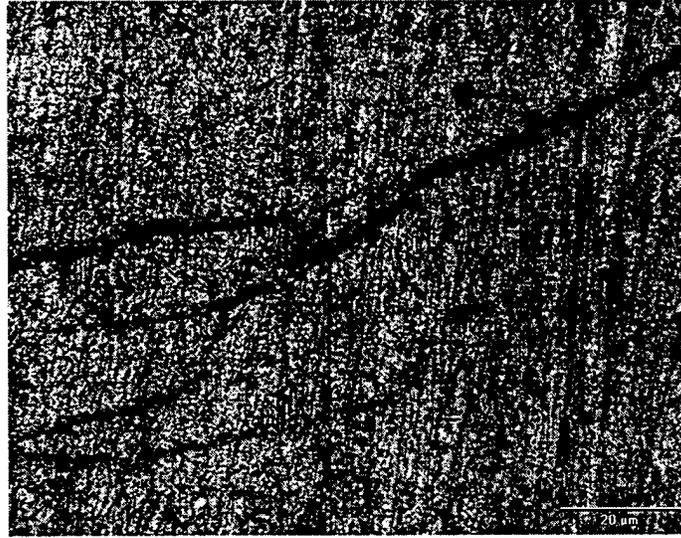
Figure 27. Laser pulsed region of unfired explosively bonded tantalum coating at magnification 2000X.

Staining throughout the pulsed region indicates that an oxide layer formed during heating. It was observed that there is a tendency for rapid oxidation of the explosively bonded tantalum during pulsing in air at ambient conditions. The surface cracks shown here are representative of those found throughout spot 1, with widths ranging from approximately 0.5 to 3.0 μm.

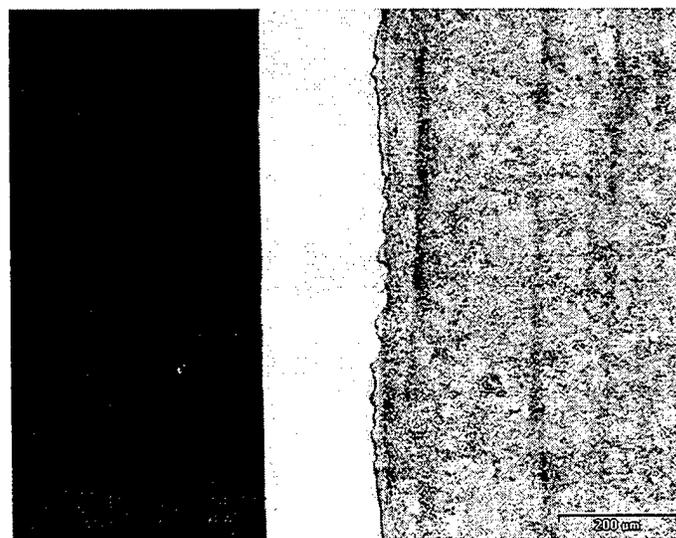
Figure 28 shows the cross-section of spot 1 taken at a magnification 200X. This image illustrates cracking of the brittle intermetallic phase, along with the formation of a small heat-affected zone in the steel adjacent to the interface. Coating thickness is approximately 210 μm within the pulsed region.

Figure 28. Laser pulsed spot 1 at magnification 200X.

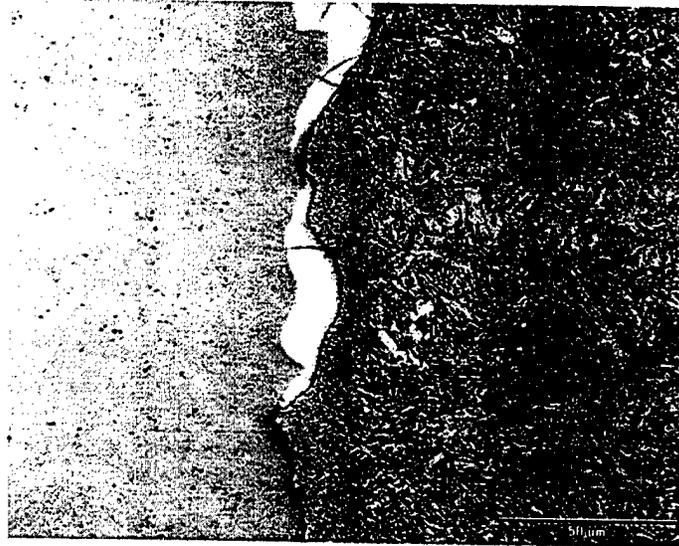
While fine cracking of the intermetallic phase was seen throughout some locations along the interface, larger cracks were found in the intermetallic phase within the laser pulsed regions. Figure 29 shows the interface of spot 1 at increased magnification.

Figure 29. Effects of laser pulsing spot 1 at magnification 1200X.

Here the heat-affected zone is seen to extend approximately 8 to 15 μm into the steel substrate. It is nonuniform, and appears along the waveform where the steel rises higher into the coating. Figure 30 shows a 2- to 3- μm thick oxide layer that has formed on the tantalum surface. Within the cross-sections of the laser-heated spots, no surface cracks have progressed through the oxide layer, suggesting that the explosively bonded tantalum is resistant to crack propagation from thermal shock.

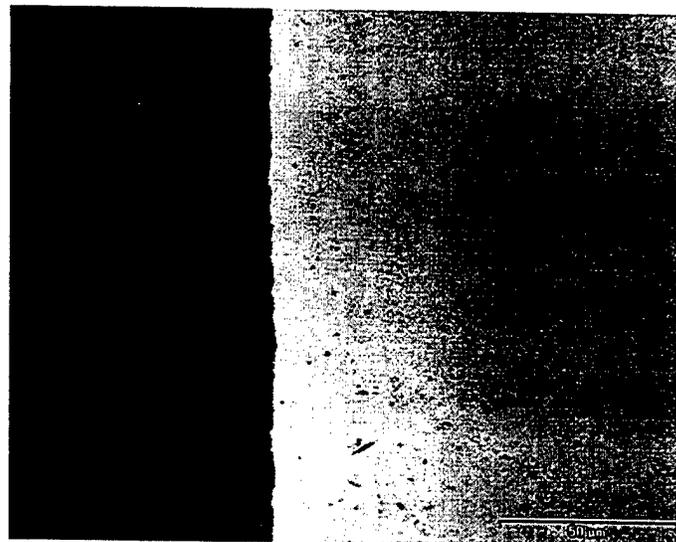
Figure 30. Surface oxide layer from laser pulsing spot 1 at magnification 2000X.

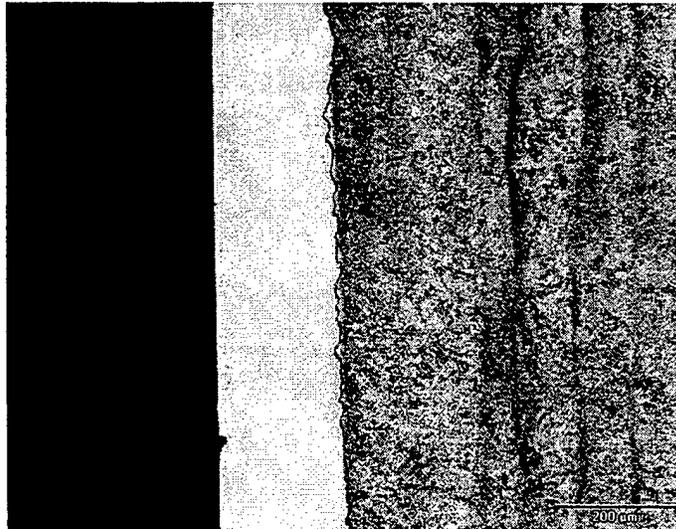
Figure 32. Laser pulsed spot 2 at magnification 200X.

Figure 32 also illustrates once again, the highly irregular interface with small regions of intermetallic phase present. A heat-affected zone is also seen in the steel adjacent to the interface. Coating thickness is approximately 210 μm within the pulsed region. Figure 33 shows this interface at increased magnification.

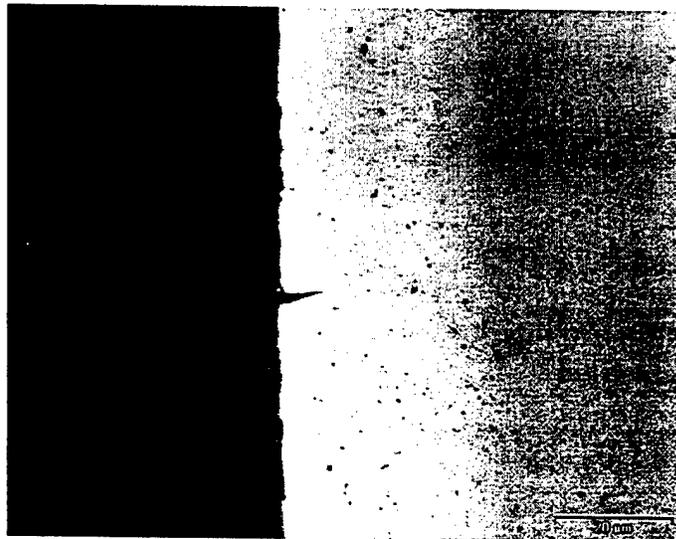
Here the heat-affected zone is seen to extend approximately 8 to 10 μm into the steel substrate. It is nonuniform and appears where the steel rises higher into the coating. Figure 34 shows a 2- to 3- μm thick oxide layer that has formed on the tantalum surface. Within the region shown, one surface crack has progressed through the oxide layer.

Figure 34. Surface oxide layer from laser pulsing spot 2 at magnification 2000X.

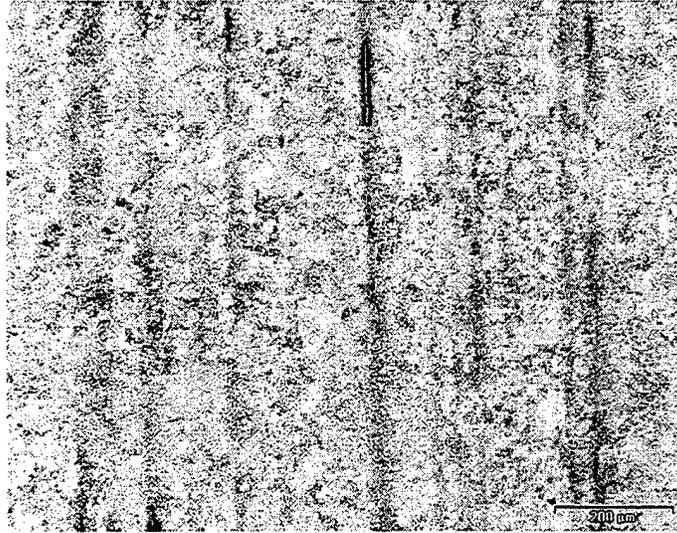
Similar to the unfired specimen, etching revealed banding parallel to the tube axis and inclusions throughout the steel substrate of Sample B, as shown in the cross-section of Figure 35.

Figure 35. Substrate steel of fired explosively bonded tantalum-coated gun tube at magnification 200X. This cross-section is perpendicular to the bore and parallel to the tube axis.

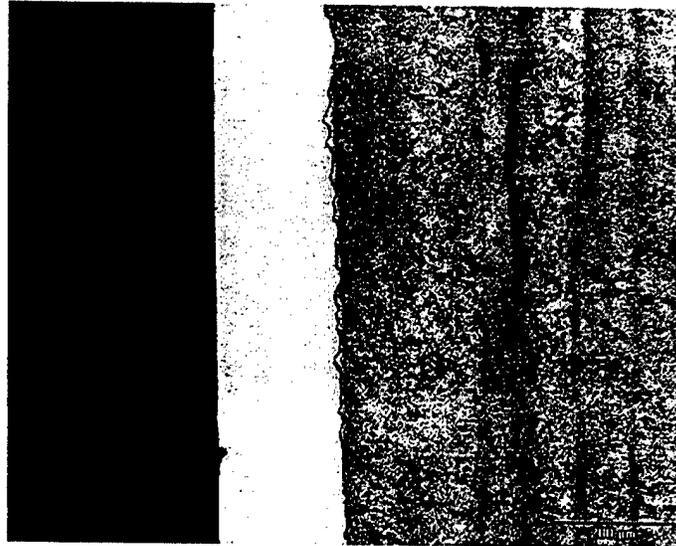
Staining throughout the pulsed region indicates that an oxide layer had formed during heating. Unlike the unfired explosively bonded coating, here the surface is found to consist of several ledge-like features. While no surface cracks are shown within this region, inspection of the cross-section in Figure 37 shows that minor surface cracking occurred.

Figure 37. Laser pulsed spot 1 at magnification 200X.

Figure 37 also shows the formation of a heat-affected zone adjacent to the irregular explosively bonded tantalum/steel interface. Coating thickness is approximately 190 μm . Figure 38 shows the interface at increased magnification. Here the heat-affected zone is seen to be fairly uniform, and extends approximately 10 to 15 μm into the steel substrate.

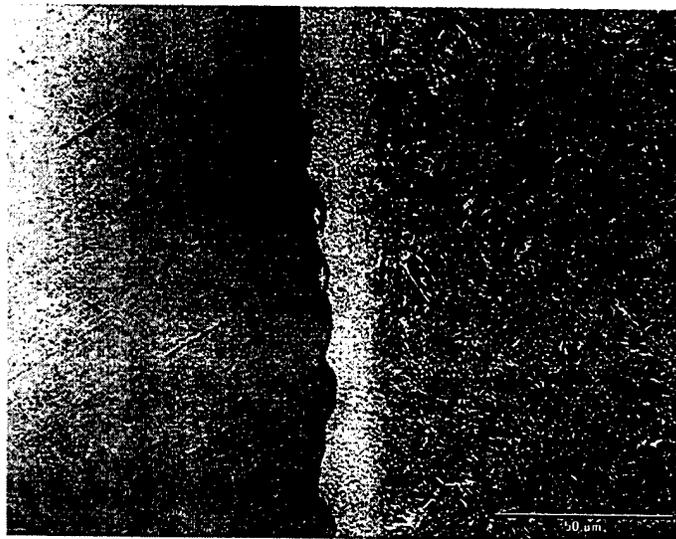
Figure 38. Effects of laser pulsing spot 1 at magnification 1200X.

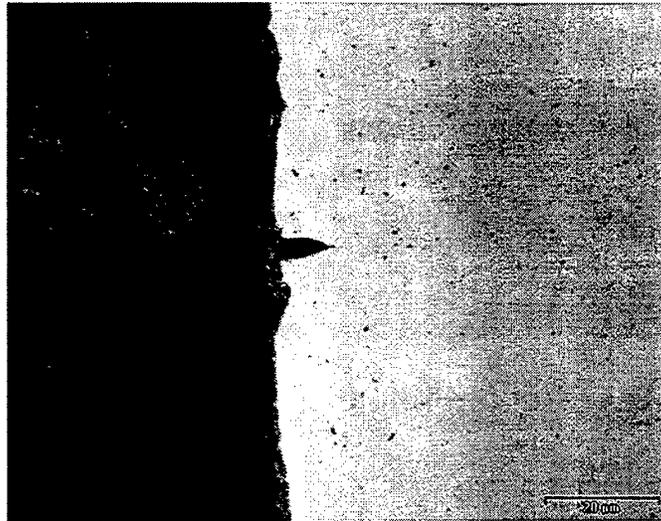
Figure 39 shows a 2- to 3- μm thick oxide layer that has formed at the tantalum surface. Here a surface crack is shown that has progressed through the oxide layer into the explosively bonded tantalum, and has propagated about 9 μm into the coating.

Figure 39. Surface oxide layer from laser pulsing spot 1 at magnification 2000X.

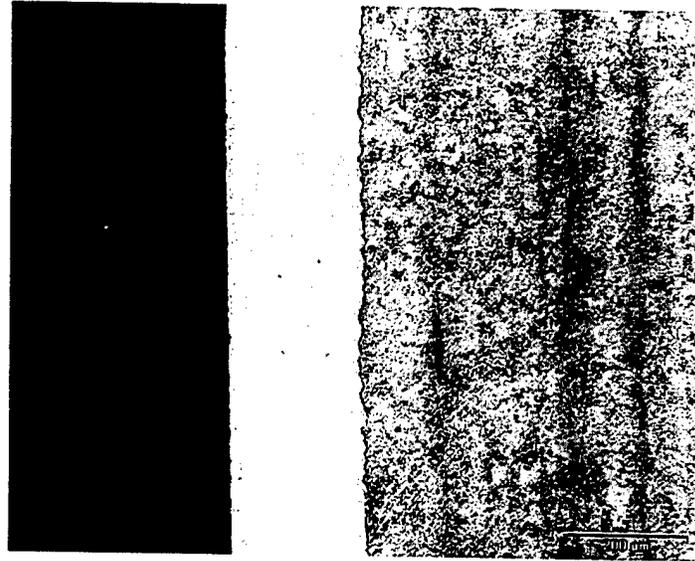
Figure 41 shows minimal formation of a heat-affected zone in the steel adjacent to the interface. This is attributed to both the lower pulse energy used at this location and an increased thickness of the explosively bonded coating as compared to spot 1. Here the average coating thickness is 230 μm .

Figure 41: Cross-section of spot 2 taken at magnification 200X.

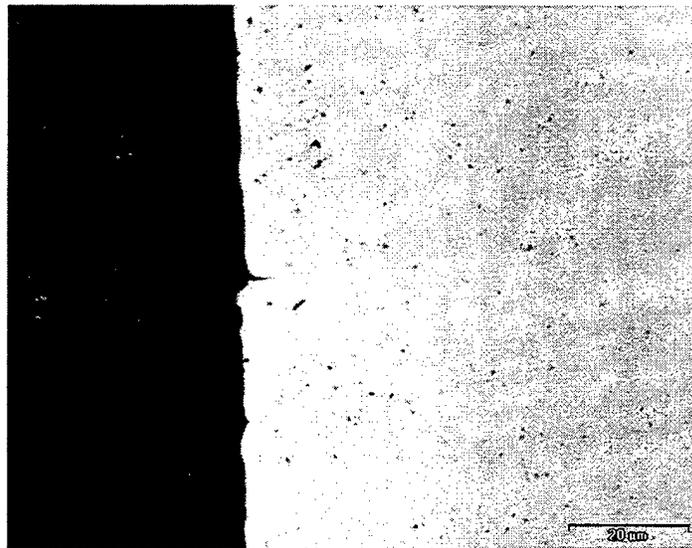
Figure 43 shows a 2- to 3- μm thick oxide layer that has formed at the tantalum surface. Within this region, one surface crack has progressed through the oxide layer.

Figure 43. Surface oxide layer from laser pulsing spot 2 at magnification 2000X.
